## WebIO7 Firmware Update (Wireless Temperature and X10) 4/29/2015

These instructions are for updating the WebIO7 Wireless Temperature and X10 protocol code. Referred to as W7R3\_RF433 firmware.

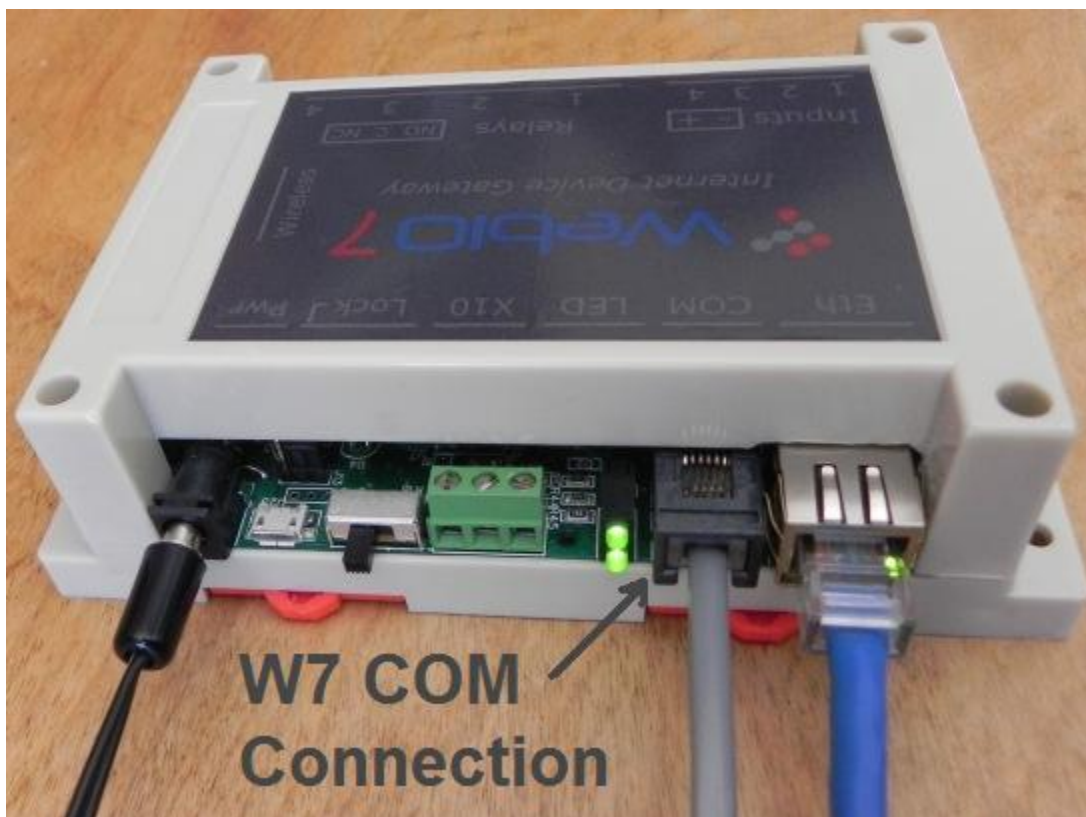
Above image shows a cable connection to WebIO7 COM 1&2 port. This firmware update uses COM1 (the COM1 pins of the COM connector. See diagram on next page).

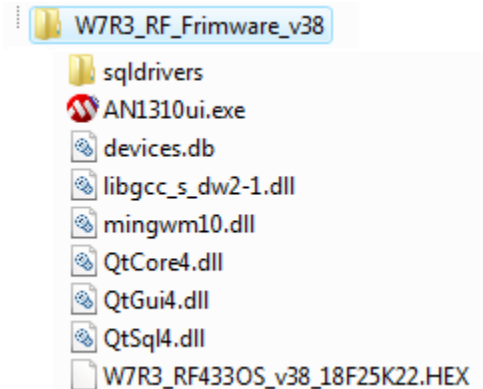
The image below lists the files included in the zip file:

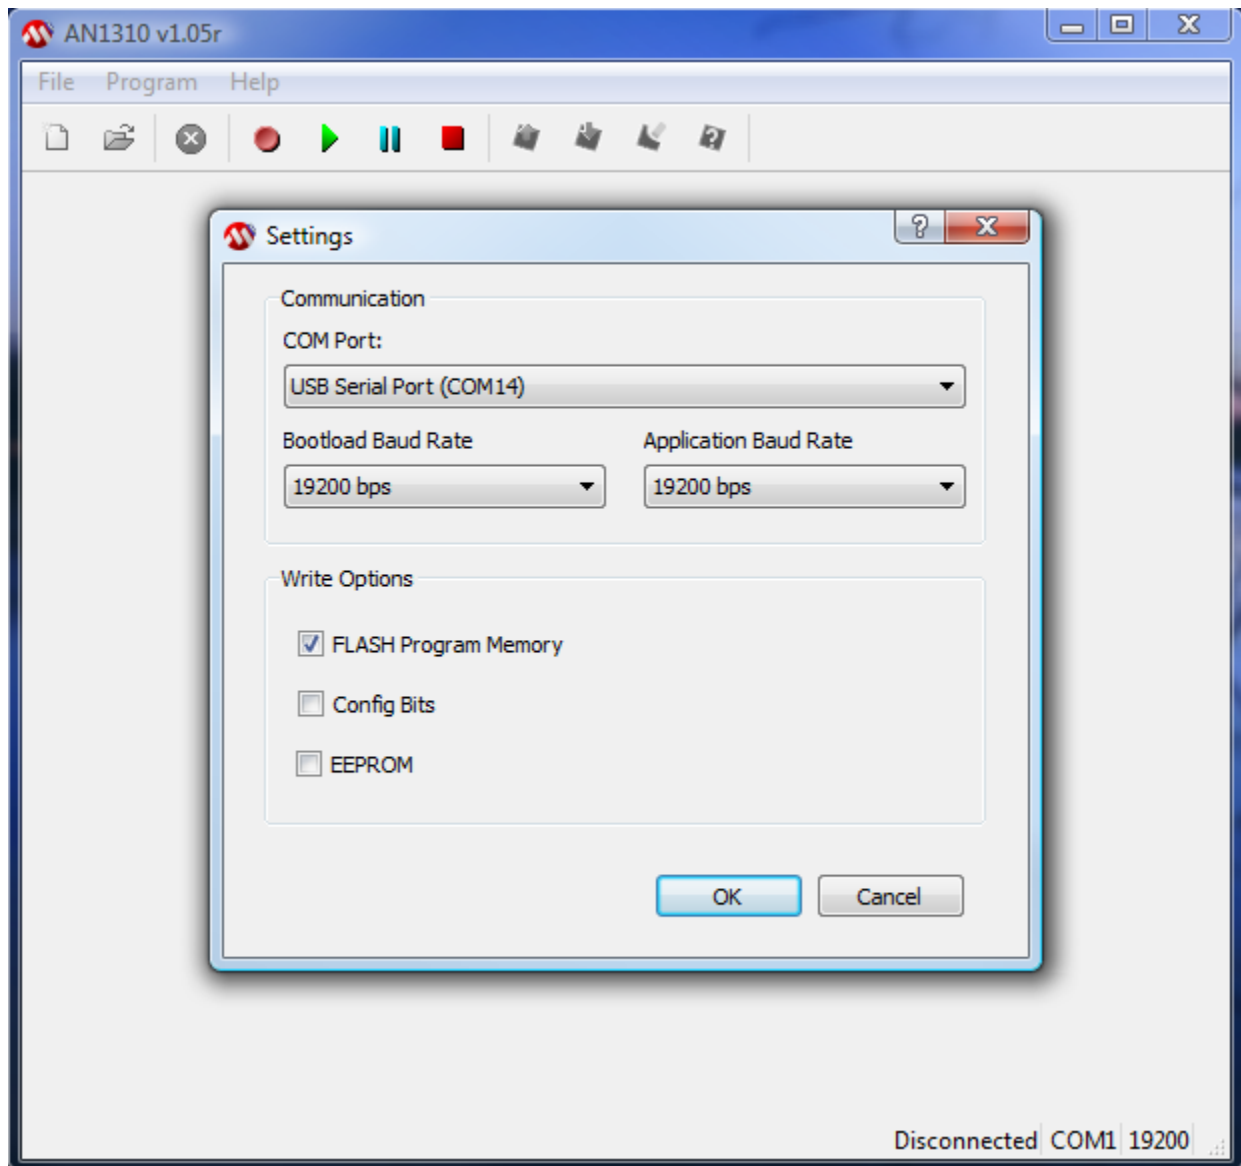
Next verify PC COM port setting. Select Program from the menu bar and select Settings. This will display the screen below:

The COM Port being used must be selected. (often hardware serial ports will have a number 1-4 where as a USB serial adapters will often have a COM number greater than 4).

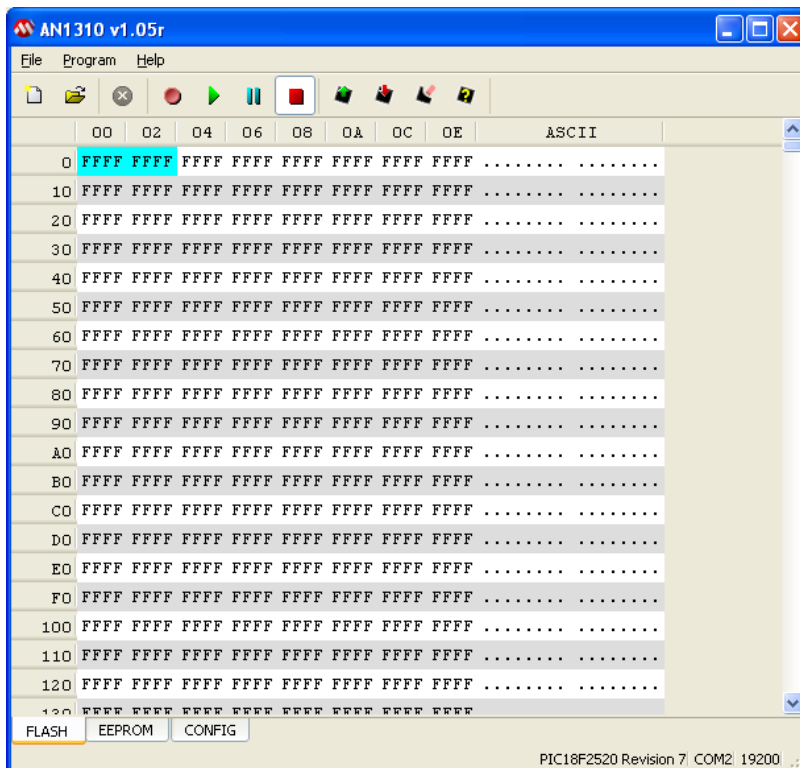
### 3) Red Stop button

After pressing the Red Stop button, the screen should look like the image below

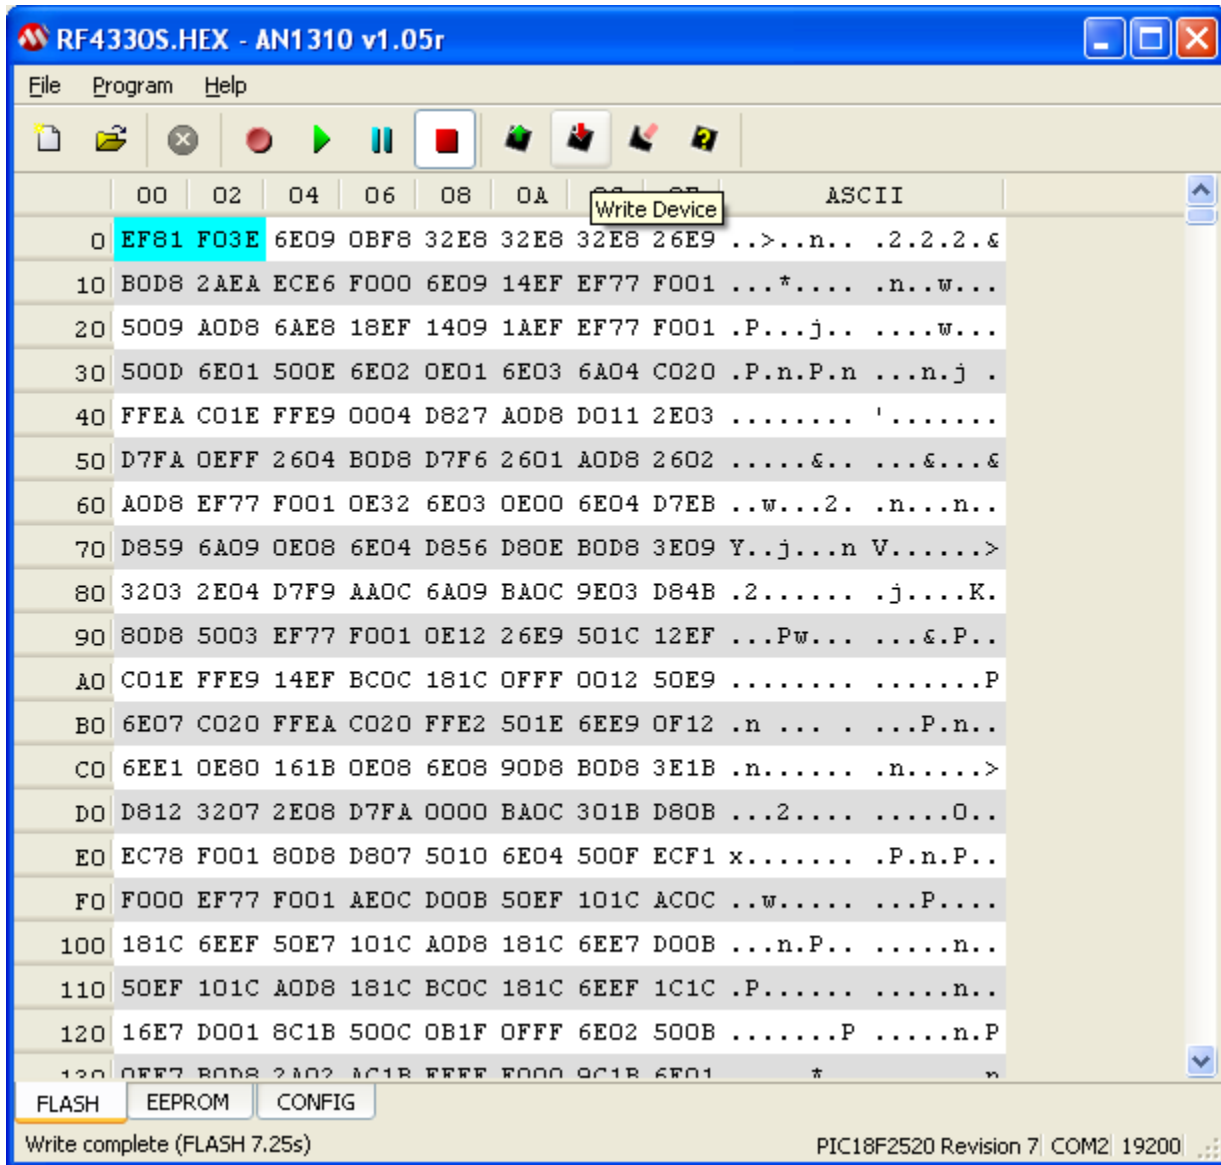
## 5) Select Write Device Button (red down arrow)

This writes the firmware image to WebIO7. This process takes about 7-8 seconds.

When complete you will see "Write complete (FLASH 7.25s)" at the bottom of the screen. The time in seconds will vary (usually 7-8 seconds). See image above.

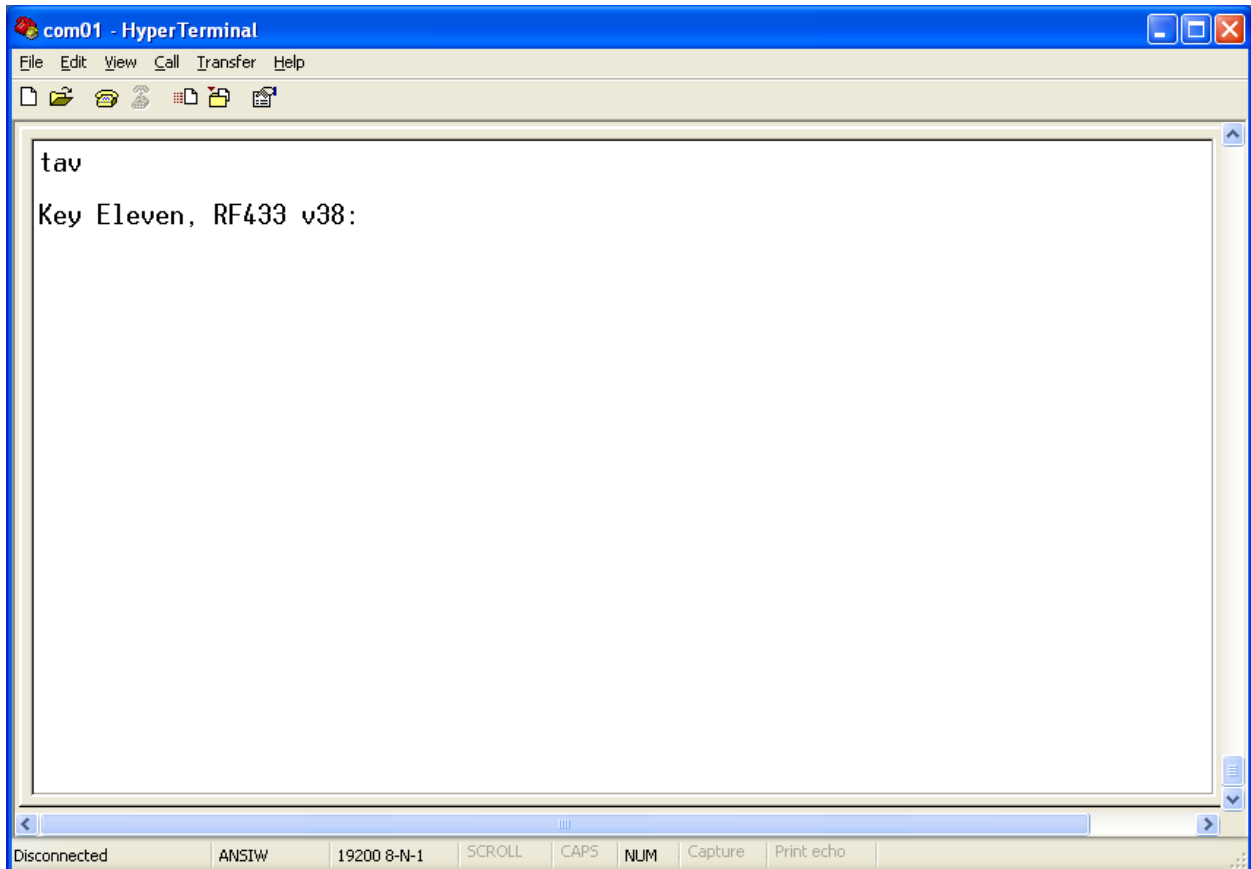
You should see the firmware version displayed in the terminal software, as in the example below (version v38).

The image shows a screenshot of a HyperTerminal window titled "com01 - HyperTerminal". The window has a menu bar with "File", "Edit", "View", "Call", "Transfer", and "Help". Below the menu bar is a toolbar with icons for file operations. The main text area contains the output "tav" followed by "Key E1even, RF433 v38:". At the bottom of the window, there is a status bar with the following information: "Disconnected", "ANSIW", "19200 8-N-1", "SCROLL", "CAPS", "NUM", "Capture", and "Print echo".

Leaving WebIO7 COM1 cable connected to the PC and the update tool closed, open HyperTerminal or other serial terminal program. This will require a baud rate setting of 19200 baud, no flow control, (8N1 None).

Reboot WebIO by removing and reapplying power. This will force WebIO7 to print it's RF software version.
